## Flooding on Somme Road and Lens Road

This document has been prepared by residents of Somme Road in reaction to Amber Valley Borough Council's change in core strategy with proposed housing development on Land West of Kedleston Road (AVBC/2013/0010).

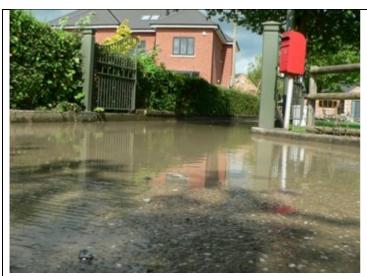
Position A on map 006 (taken 10th Aug 2014)

As part of planning conditions of Somme Road developments, new build houses were required to increase ground levels above the road level, improve drainage ditches and build retaining walls to protect dwellings from flooding. This has had impact on existing dwellings, as water tends to accumulate on lower plots of land. Some residents on existing plots tend to experience standing water on lawns and driveways, which can accumulate into vast amounts of water during long spells of rainfall. See images below:
