## Flooding on Somme Road and Lens Road

This document has been prepared by residents of Somme Road in reaction to Amber Valley Borough Council's change in core strategy with proposed housing development on Land West of Kedleston Road (AVBC/2013/0010).

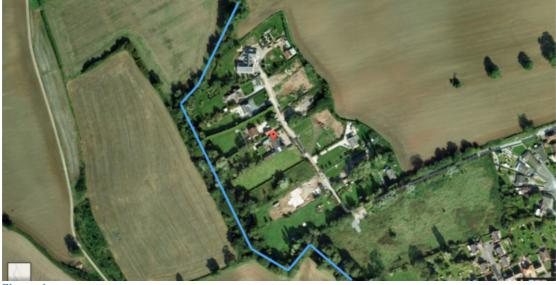
Figure 1

Somme Road is located in a valley and sits closely to the Markeaton Brook (see figure 1). Historically, the road had only 6 original dwellings, which were spread across the site with large areas of land around. The land around Somme Road was predominantly boggy land with bad drainage and many areas prone to standing water.
